SERVICE BULLETIN

EC00-010C

ITB00-026C

2000 - 2002 G20 SULFUR OR "ROTTEN EGG" ODOR FROM EXHAUST

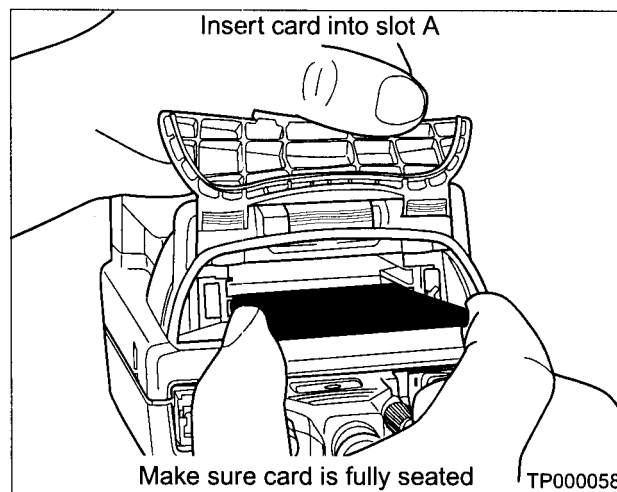
Figure 1

1. Install the ECM Reprogramming Software Card (orange) into slot A of CONSULT-II (see Figure 1).

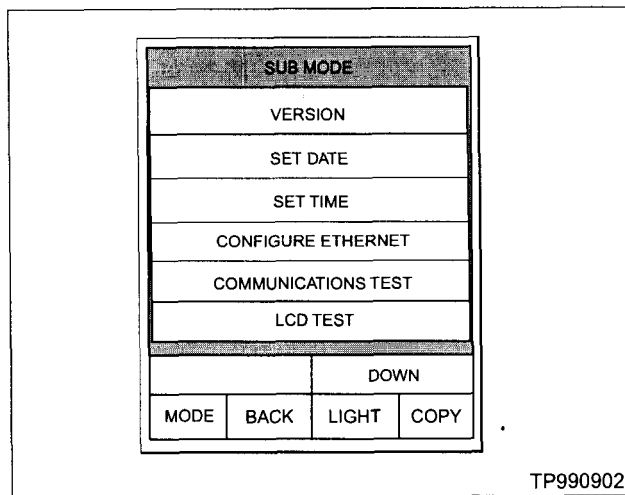
Figure 2

3. Confirm the CONSULT-II date and time is correctly set as follows:
 - A. With the ECM Reprogramming Software card in slot 1, turn on CONSULT-II.
 - B. Touch "Sub Mode".

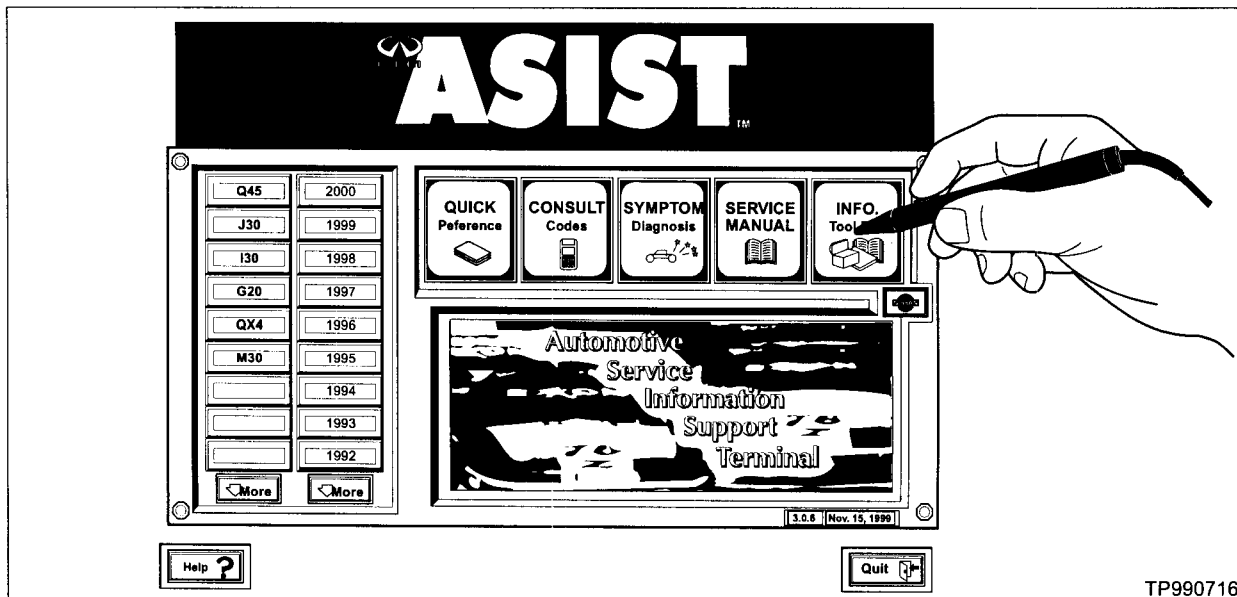
Figure 6

- I. Turn off CONSULT-II to allow the new Address to be saved in memory.
 - J. On the ASIST PC close the "IP Configuration" window, close the "MS-DOS Prompt" window, then proceed with step 5.
5. Launch ASIST. From the ASIST PC main menu screen, select "INFO. Tool Box" (see Figure 6).

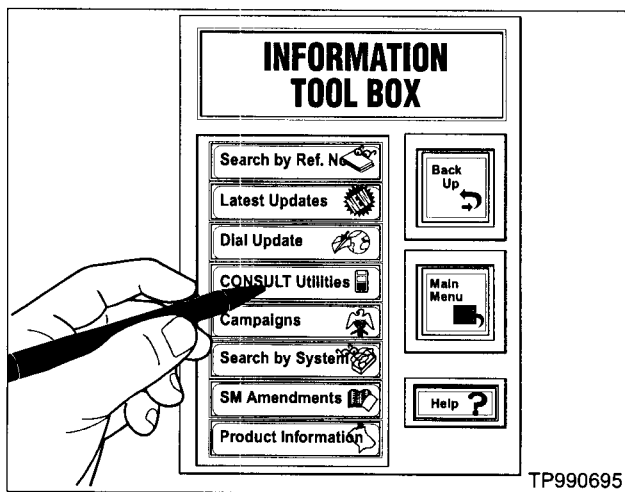
Figure 7

6. From the "INFORMATION TOOLBOX" screen, select "CONSULT Utilities" (see Figure 7).

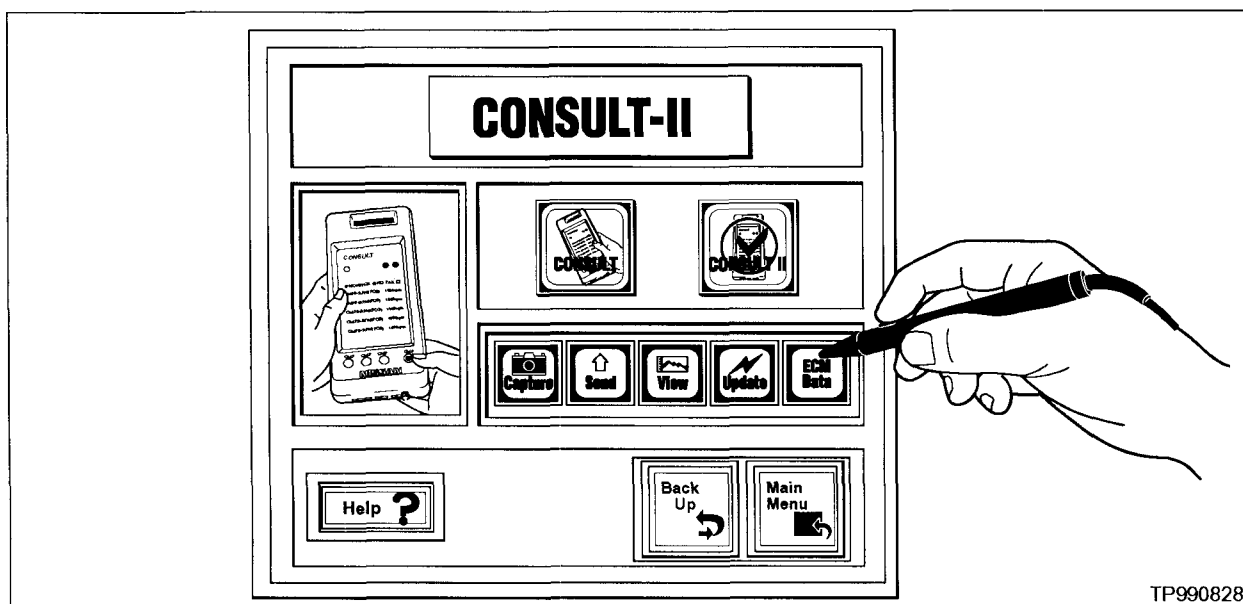
Figure 8

7. From the "CONSULT Utilities" screen, select "CONSULT-II", then select "ECM Data" (see Figure 8).

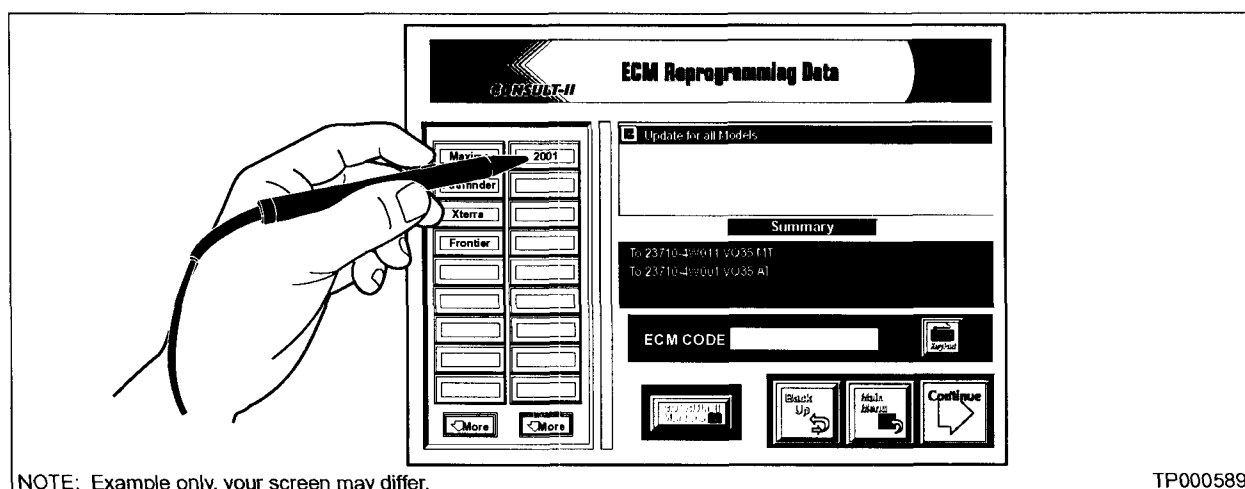
Figure 9

8. The "ECM Data Reprogramming" screen will be displayed (see Figure 9):

NOTE: Example only, your screen may differ.

- A. Select model and model year for the applied vehicle.
- B. Select the applicable vehicle configuration for your vehicle from that listed in the upper right ECM data description window.
 - If "Update for all Models" is the only listing, go to step C.
 - If multiple selections are listed (M/T vs A/T, Fed vs Cal, ect.), select the applicable vehicle configuration then go to step C.
- C. Click the "Continue" button on the ECM Data Reprogramming screen to proceed to CONSULT-II setup.

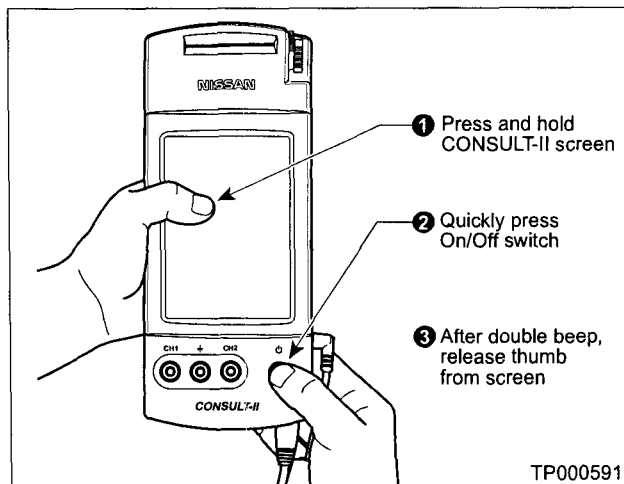
Figure 10

- A. While pressing on the CONSULT-II screen with your thumb, quickly depress and release the ON/OFF switch (see Figure 10).

NOTE: A double-beep will sound after the ON/OFF switch is quickly depressed and released.

Release your thumb from the screen after a double-beep sound is heard.

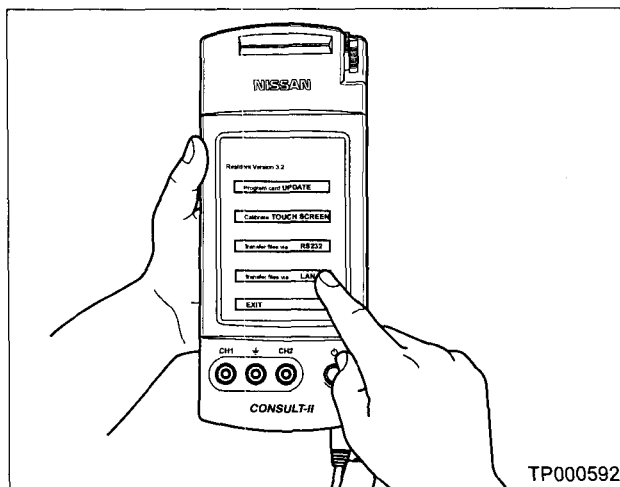
Figure 11

- B. Select "**Transfer files via Lan**" (see Figure 11). Set the CONSULT-II unit down for now.

NOTE: If you accidentally choose a menu option other than "**Transfer Files via Lan**", turn CONSULT-II off and restart it according to step 9A above.

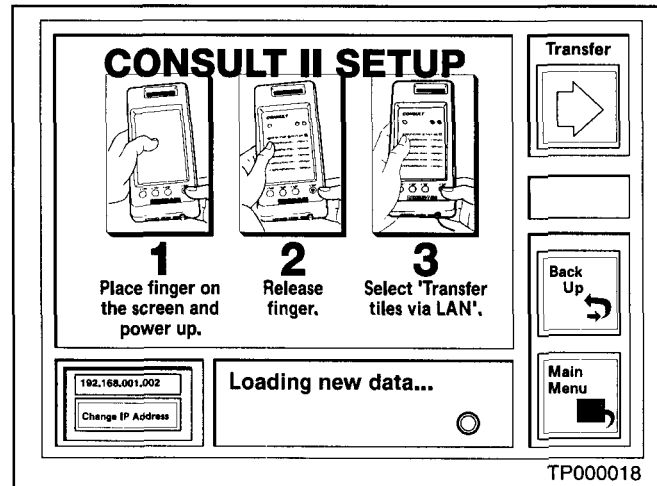
Figure 12

11. Click "Transfer." Data transfer will take about 1 minute and the progress of the transfer is displayed on the ASIST PC screen (see Figure 12). Wait until the data transfer is complete (see **CAUTION**, below).

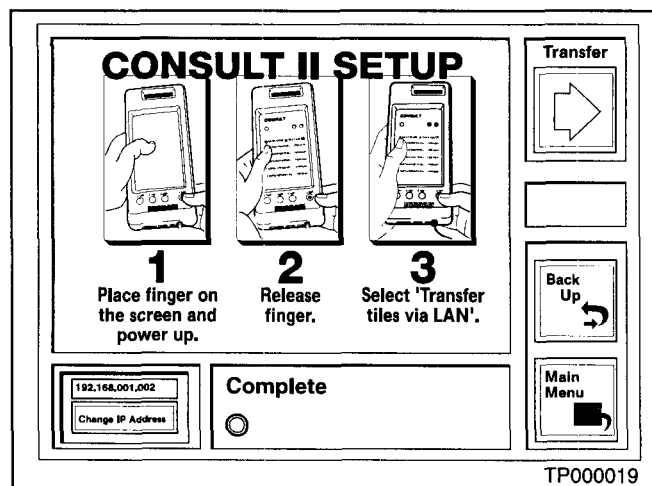
Figure 13

CAUTION: DO NOT DISCONNECT THE ETHERNET CABLE UNTIL "COMPLETE" IS DISPLAYED AS SHOWN IN FIGURE 13. If the cable is disconnected before "Complete" is displayed you **MUST** restart the download procedure. Otherwise ECM damage can occur. If the cable is disconnected during the transfer; close ASIST, push "Control/Alt/Delete" and select End task. Then return to step 5 on page 4.

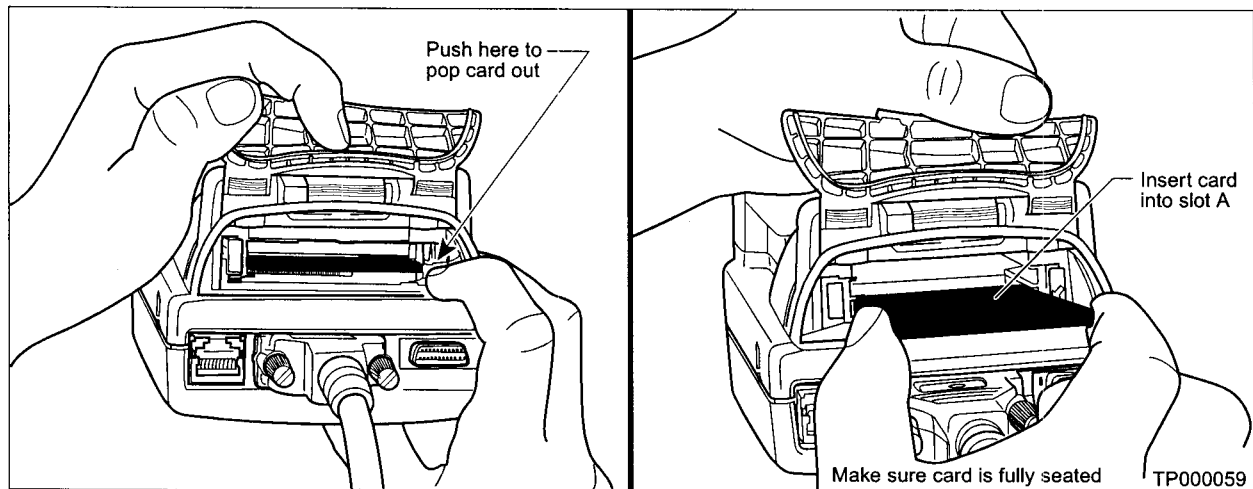
Figure 14

15. Remove the ECM Reprogramming card from slot A of CONSULT-II and install the Diagnostics (blue) card into slot A (see Figure 14).

CAUTION: Do not use slot B.

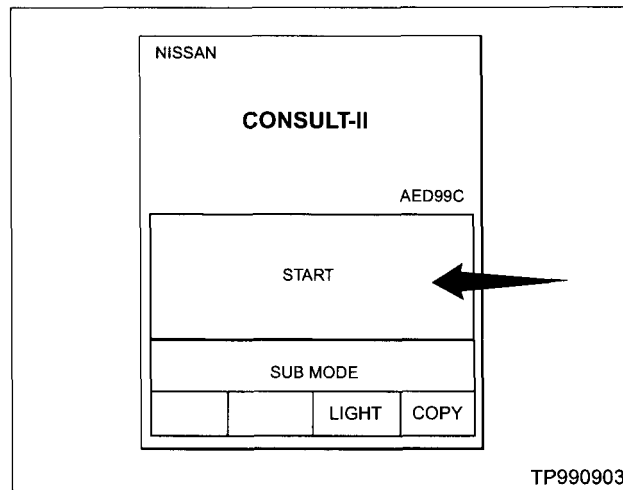
Figure 15

16. Turn "ON" the ignition switch (do not start the engine). CONSULT-II will turn on automatically (see Figure 15).

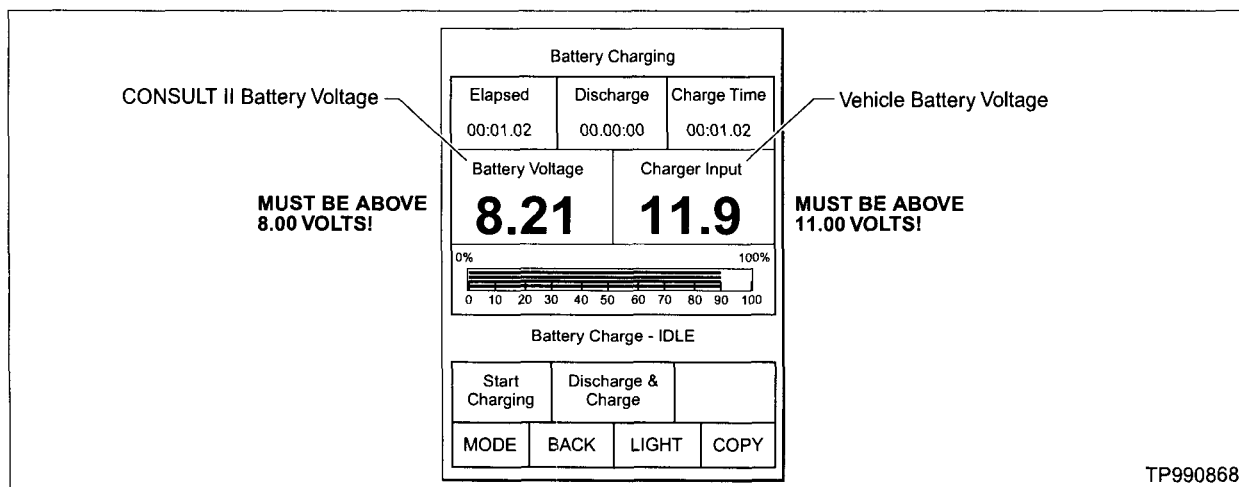
Figure 16

21. Refer to Figure 16. The vehicle battery voltage is "Charger Input". "Battery Voltage" is CONSULT-II's battery voltage.

- If the vehicle battery voltage ("Charger Input") is less than 11 volts, charge it properly/replace it before proceeding with ECM Reprogramming.
- If CONSULT-II's battery ("Battery Voltage") is less than 8 volts, disconnect CONSULT-II and charge its battery before proceeding with ECM Reprogramming.
- If the batteries are within specification, proceed to step 22.

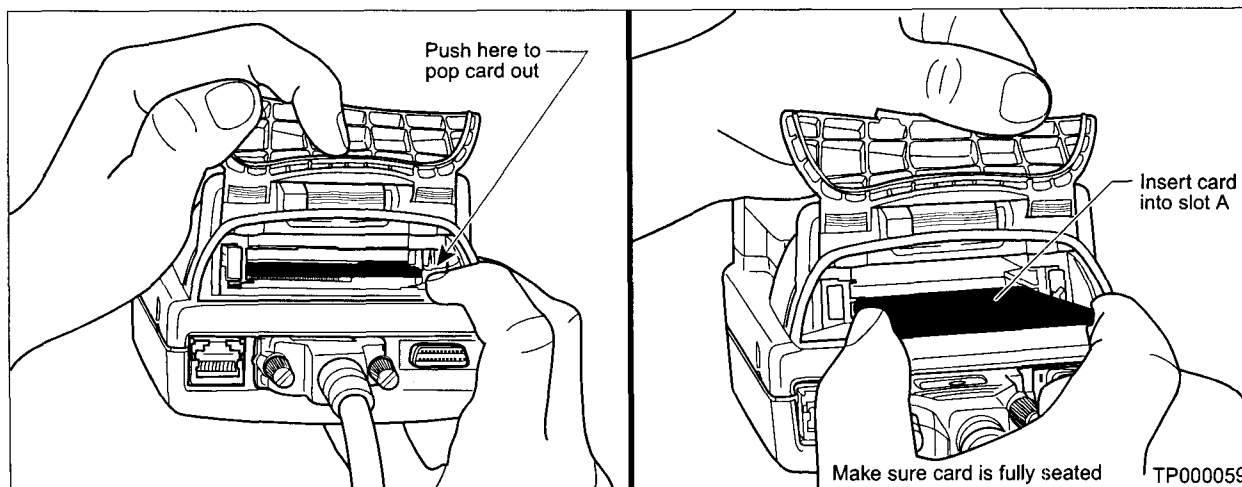
Figure 17

23. Remove the Diagnostics (blue) card from slot A of CONSULT II and install the ECM Reprogramming card (orange) into slot A (see Figure 17).

CAUTION: Do not use slot B.

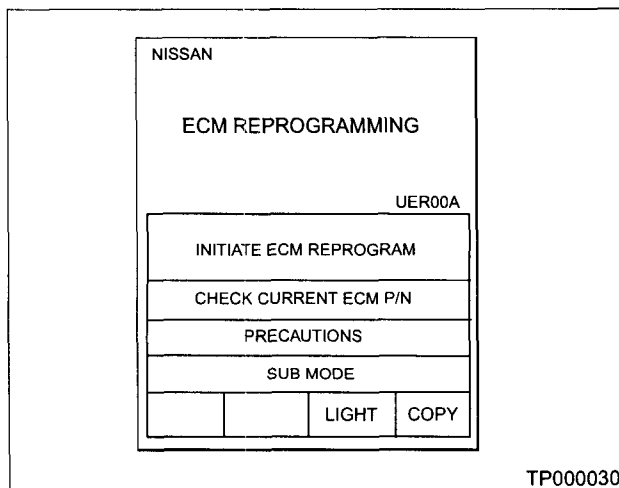
Figure 18

24. Make sure the DLC-II cable is firmly plugged into the vehicle harness (see **CAUTION** below). Turn "ON" the ignition switch (do not start the engine). CONSULT II will turn on automatically (see Figure 18).

NOTE: ALL Reprogramming operations are done with the DLC-II cable ONLY.

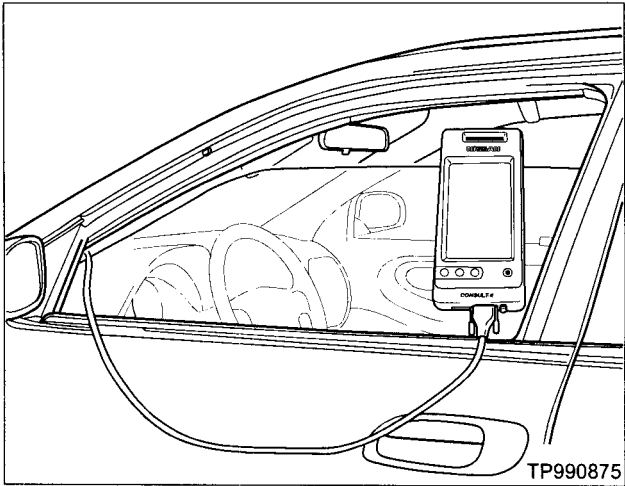
Figure 19

26. Roll down the driver's window part way, exit the vehicle, close the door and hang the CONSULT II unit on the outside of the window (see Figure 19).

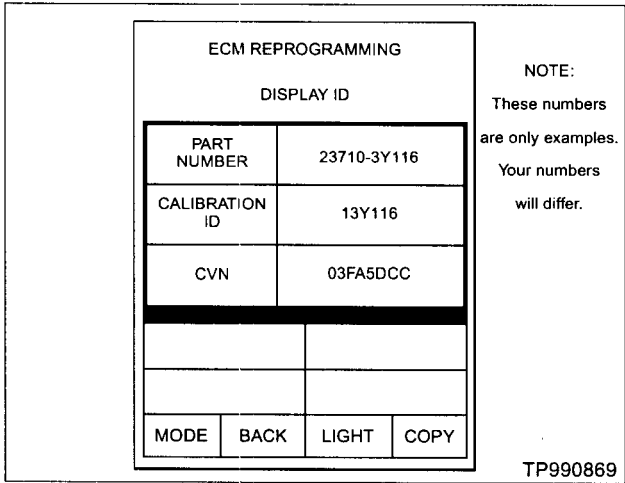
Figure 20

27. Press "CHECK CURRENT ECM P/N" to confirm the ECM part number on the vehicle to be reprogrammed (see Figure 20).

NOTE: This is the ECM part number BEFORE Reprogramming.

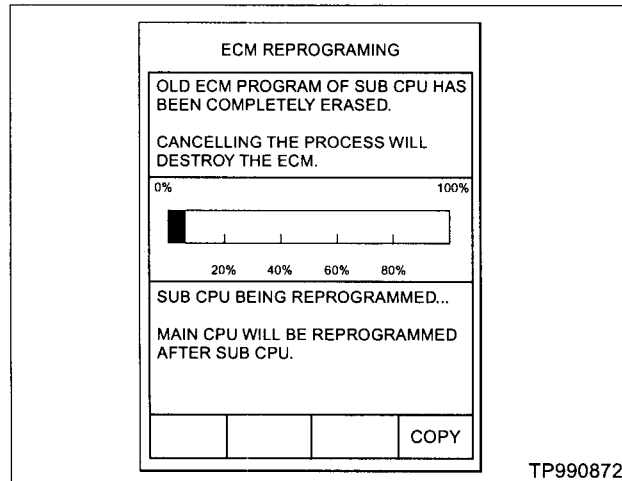
32. Press "START". After a moment the window shown in Figure 23 will appear. CONSULT-II will now turn off its screen backlight and reprogram the ECM.

When the Reprogramming is complete, CONSULT-II will "beep", turn the screen backlight back on and automatically print out a report.

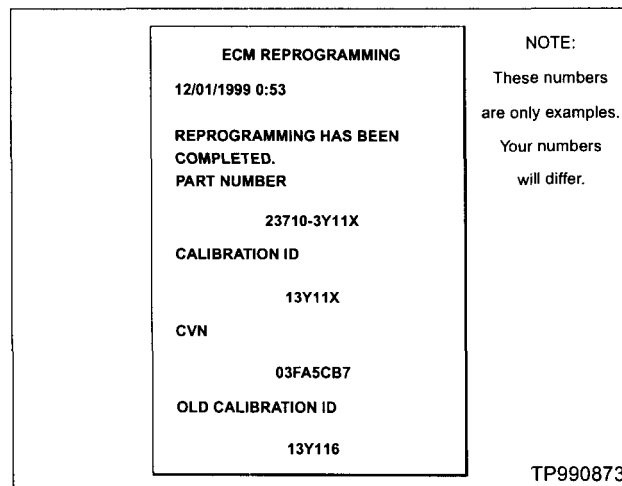
Figure 24

33. Once ECM Reprogramming is done, CONSULT II will print out a report (see Figure 24). Attach this to the repair order for future reference.

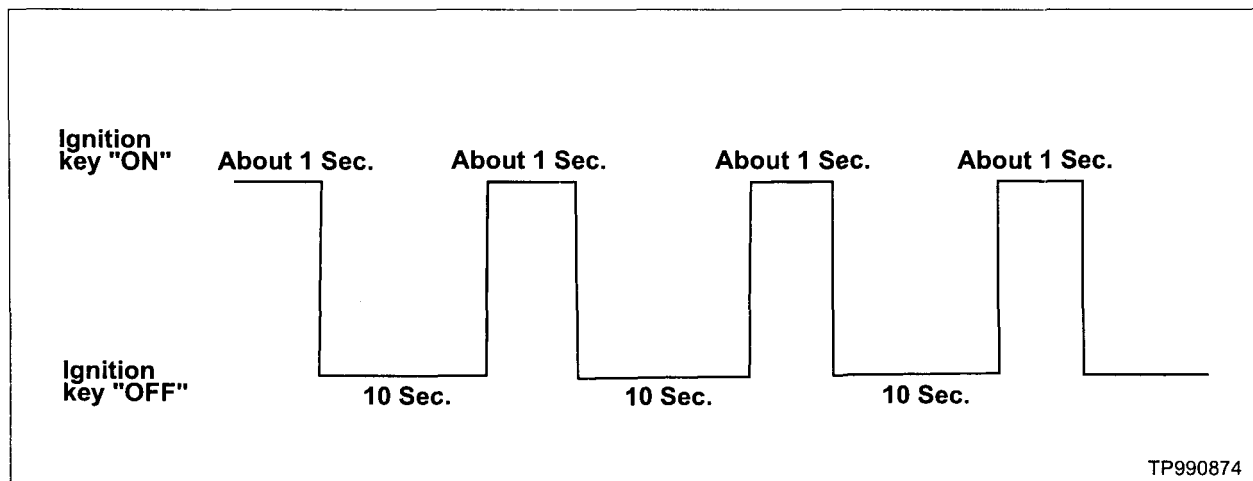
Figure 25

34. Press "END" to return to the main menu. Enter the vehicle and turn the ignition switch "OFF" and CONSULT-II off. Disconnect CONSULT-II from the vehicle.
35. **Wait more than 10 seconds, then turn the ignition switch "ON" for 1 second. Then, turn the ignition switch "OFF" again for 10 seconds.**
36. **Repeat step 35 for a total of three times (see Figure 25). This will reset ECM "self learned" values.**
